**Hazardous Materials Survey & Lead Paint Risk Assessment for the  
Fritz Peak Observatory Located in Rollinsville, Colorado  
National Oceanic & Atmospheric Administration (NOAA)  
Office of Oceanic and Atmospheric Research (OAR)**

November 2019  
EA Project No. 6323506

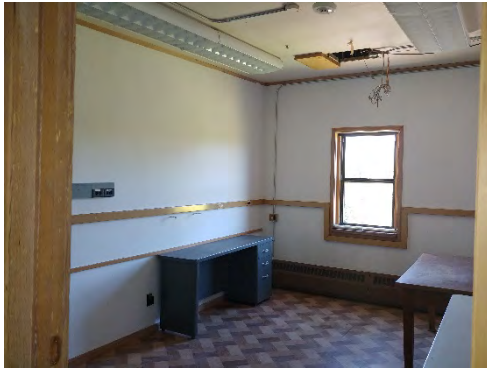
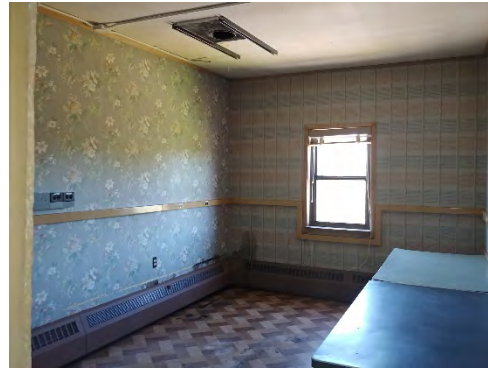
**Composite drywall w/joint compound walls, ceilings throughout all 3 floors (CDW01, 02, 03, 04) and MA02 - walls w/wallpaper**

Seven of the homogeneous areas of asbestos-containing materials identified at the building (presented in Table 1 in Section 3.0 Results) were observed to be non-friable and in good condition. Two homogeneous areas of asbestos-containing materials identified at the building were observed to be friable and in good condition. These materials should be removed if the building is to be demolished or if these materials are to be disturbed during building renovation activities. Proper federal and state regulations governing pre-alteration ACM removal must be followed. Removal of ACM must be conducted by properly licensed and accredited individuals working for a licensed asbestos abatement contractor.

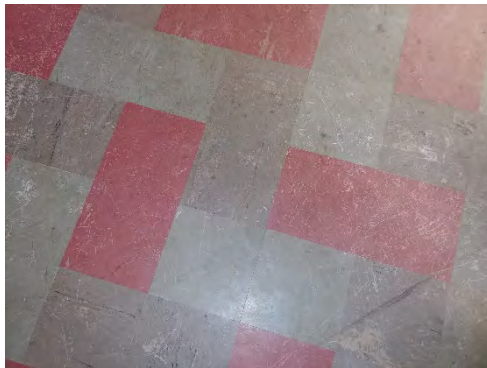
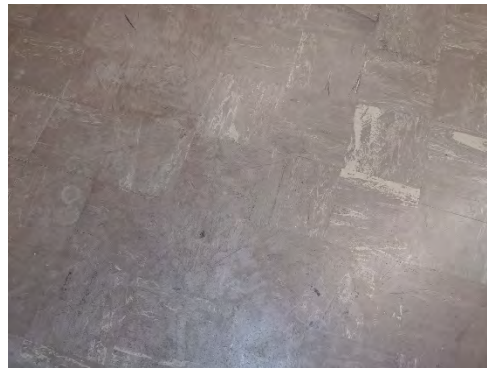
**FTM02- 9x9 floor tile rose, gray and green  
Throughout 2<sup>nd</sup> floor rooms (tile only)**

**FTM03- 9x9 floor tile brown**

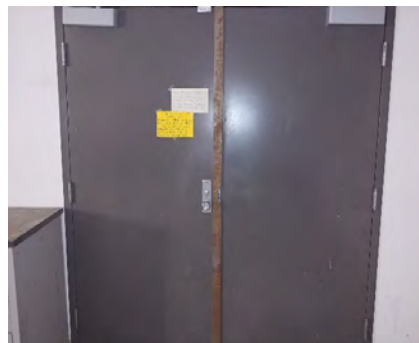
**FDM01-Fire door material-ASSUME**

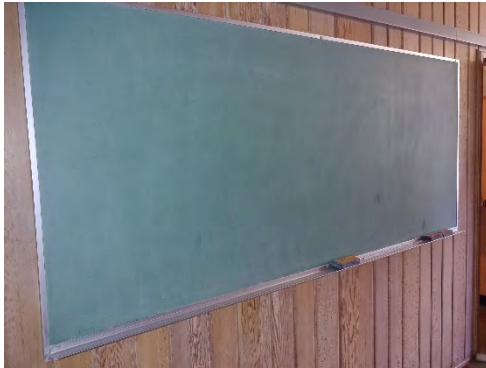
**OT01- ASSUME all Chalkboards**

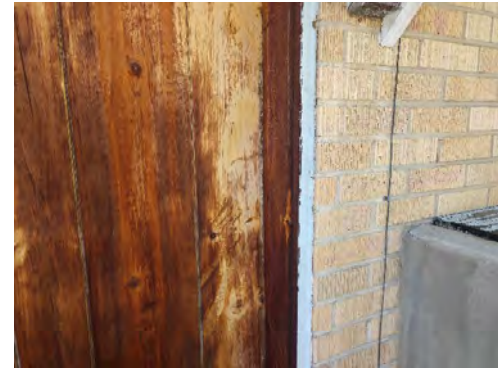
**CK03- exterior Storage Rm, door frame**

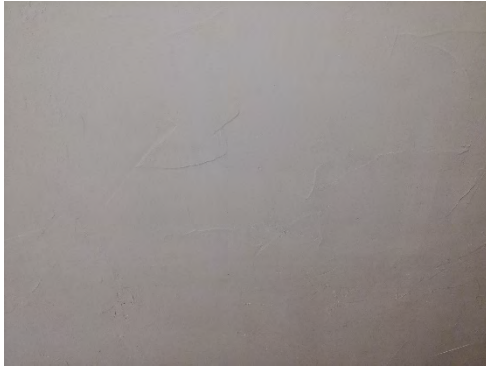
**TS01- Trowel texture - ceilings 2<sup>nd</sup> fl;**

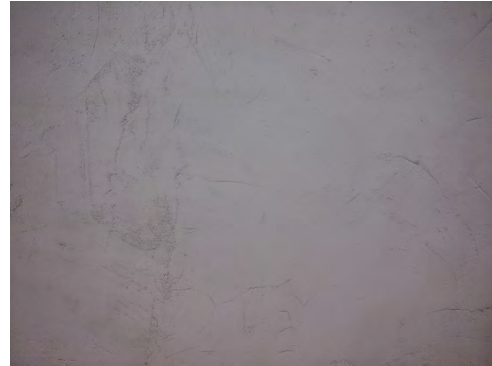
**TS02 Heavy Trowel texture-ceilings 2<sup>nd</sup> fl**

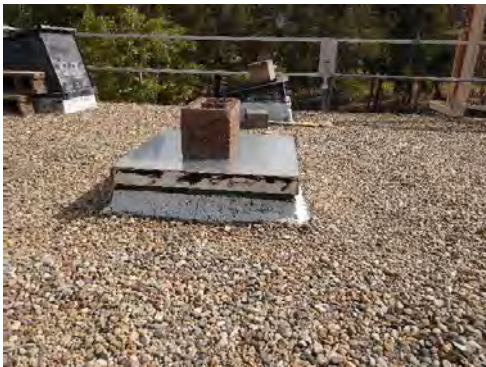
**RF01- Roof Flashing**

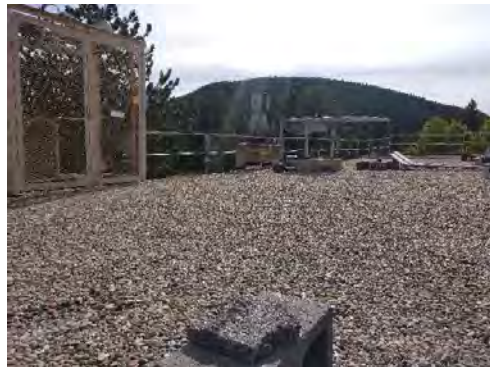
**RT01-Roofing Tar**

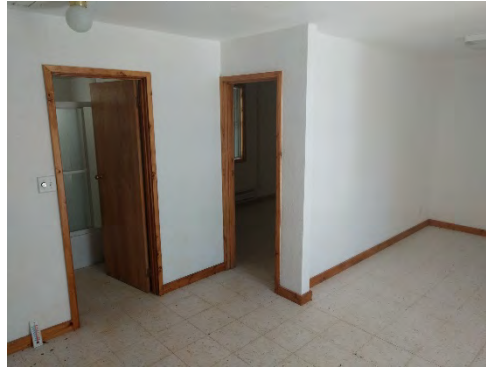
Homogenous Area	Material Description	Material Location	Quantity	Condition	Friability	Result
TS03	Heavy orange peel texture on drywall	Interior walls and ceilings	1,000 SF	Good	Friable	2% Chrysotile

**TS03 – Texture on walls/ceilings**

Asbestos-containing materials identified at the building (presented in Table 2 in Section 3.0 Results) were observed to be friable and in good condition. These materials should be removed if the building is to be demolished or if these materials are to be disturbed during building renovation activities. Proper federal and state regulations governing pre-alteration ACM removal must be followed. Removal of ACM must be conducted by properly licensed and accredited individuals working for a licensed asbestos abatement contractor.

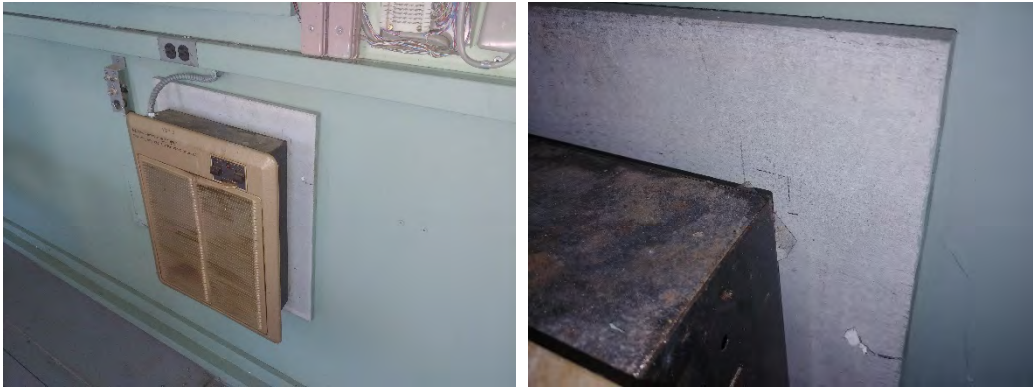
**CB01- cement board behind wall mounted heaters**

Asbestos-containing materials identified at the building (presented in Table 3 in Section 3.0 Results) were observed to be non-friable and in good condition. These materials should be removed if the building is to be demolished or if these materials are to be disturbed during building renovation activities. Proper federal and state regulations governing pre-alteration ACM removal must be followed. Removal of ACM must be conducted by properly licensed and accredited individuals working for a licensed asbestos abatement contractor.

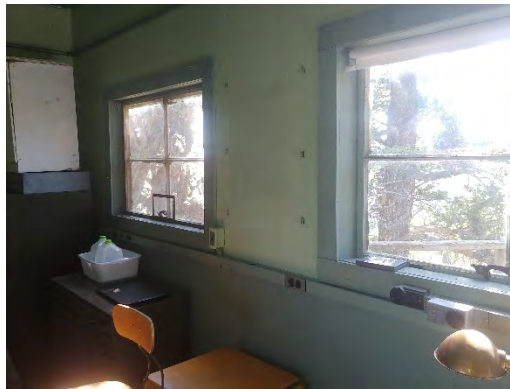
**CDW06- composite drywall w/joint compound- walls**

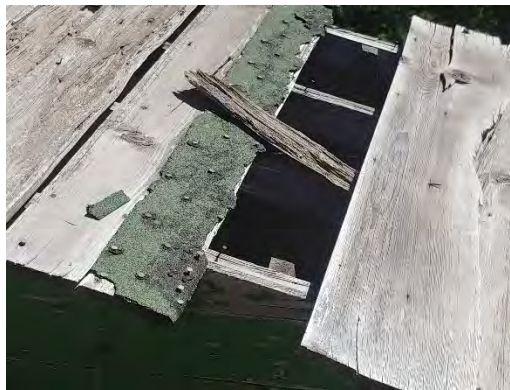
**RSG02-asphalt roofing shingles on wood storage shed**
